# GLEASON LIBRARY STUDY

## Existing Conditions & Treatment Recommendations

Prepared for the:  
**Town of Carlisle**

### Existing Conditions Report, Treatment Recommendations and Maintenance Priorities for the Gleason Public Library

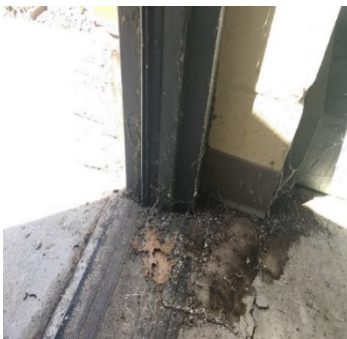
*Threshold at rear egress door with damaged concrete slab.*

**Treatment Recommendation:** We recommend cleaning the damaged area of the slab, repairing the cracks and other disintegration and resealing it.

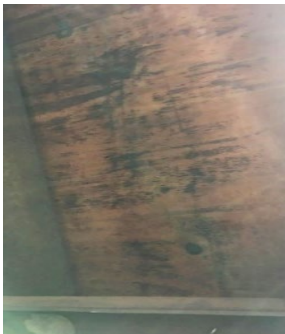
*Mildew growing on plywood of roof deck over gabled entrance.*

There are two small gabled areas over the east and west entrances of the addition. We were able to observe the wooden rafters and decking from the interior of gabled area. We noted that these areas are not vented properly, and that mildew is present on the plywood decking.

The condition of the structure under the asphalt roof at the gabled entrances is in fair condition. The rafters are good, but the plywood decking has mildew growing on it and some warping is observed. If the plywood decking is damaged it should be replaced; otherwise it should be treated for mildew.

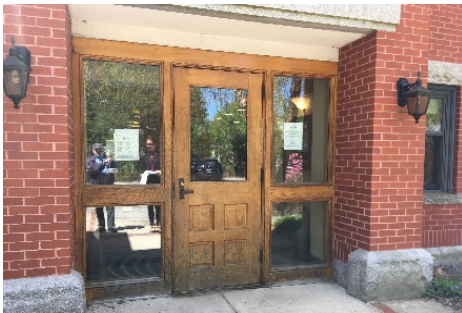
*East Main Entry Door*

The East and West main entry exterior doors are two paneled, wood and glass doors, set in wood frames. There is a glass vision panel on the top of each door. The protective finish on the main doors is peeling. We note some cracking and graying of the wood. All four doors are motorized with ceiling mounted operators and push button operators adjacent to the doors. The staff reported to us that the door opening mechanism is of concern. Due to the sticking the motor works harder than it might have to, and the doors remain open too long. Doors, seals and stops are in fair condition.

East and West Main Entrance Doors: The doors should be scraped, sanded and re-sealed. The opening and closing mechanism should be adjusted for proper operation and to contain conditioned air inside the building.

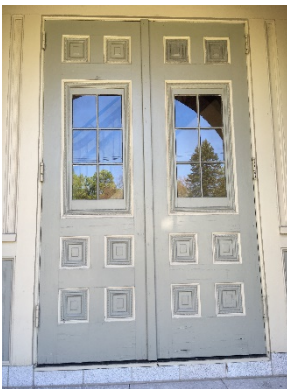
*North Egress Doors*

The North egress doors (the original main entrance) are wood and glass and the South egress door is metal. The North egress door (formerly the main door) is dirty. The South egress door is rusting and sticking and is not completely sealed at the bottom. This has led to water infiltration which has damaged the concrete slab in the Southeast corner as noted in the previous section.

Egress Doors: The south egress steel door and frame should be scraped free of rust, primed and painted. Alternatively, due to the damage already suffered, consider replacement of the door and the frame. Add an exterior surface mounted sweep to prevent water from entering. The north egress door and alcove area should also be cleaned.

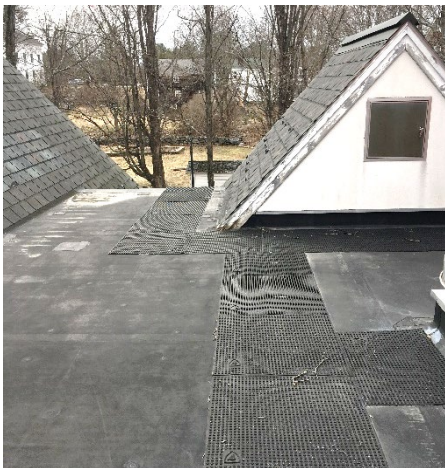
Flat EPDM Roof: The EPDM covering is at the end of its life cycle and is in poor condition.

The library stakeholders reported that the roof leaks in numerous places in the wintertime,

*Flat roof at new addition.*

and drips into the habitable areas of the upper level of the addition. The rigid insulation under the EPDM appears to have been saturated due to the roof leaks

**2000 Addition–Flat EPDM Roof:** This roof is leaking and should be replaced. There are testing methods which can establish whether the rigid insulation under the roof deck is waterlogged. These tests should be performed immediately to determine the condition. If the insulation is wet, it should be replaced and the roof deck underneath should be examined to determine whether it is damaged and in need of repair. The flashing details should be modified to provide a deeper basin and to prevent leakage as indicated above.

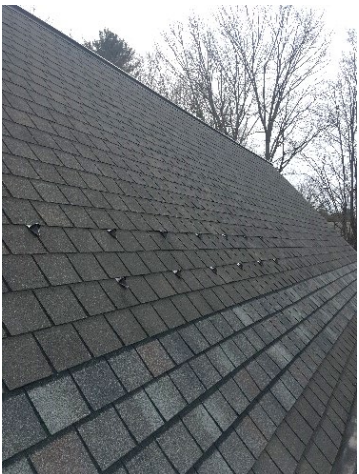
*Four courses of shingles which replaced venting on roof of addition.*

**Asphalt Shingle Roof:** This roof covering is near the end of its life. The shingles are warped on the southern exposures, which may be due to the lack of ventilation. While the flat roof is replaced, this roof should be investigated further to determine whether it should also be replaced. As discussed, the flashing for the flat roof should extend two feet up from the flat roof. This roof also needs to be better ventilated. The ventilation system that was taken out needs to be restored. Methods of ventilation should be explored in detail when the roof work is commissioned. Any ventilation should be raised up from the flat roof, so it does not become blocked with the snow in winter.

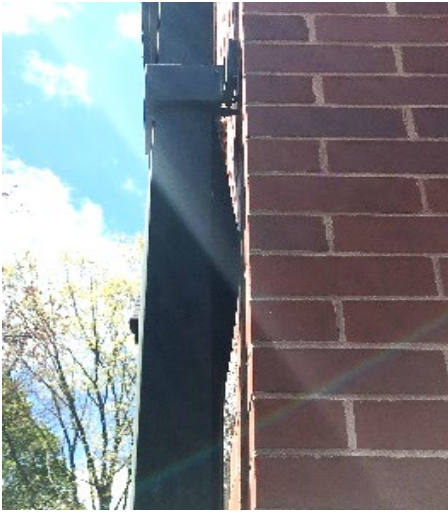
*Open seam at back of downspout.*

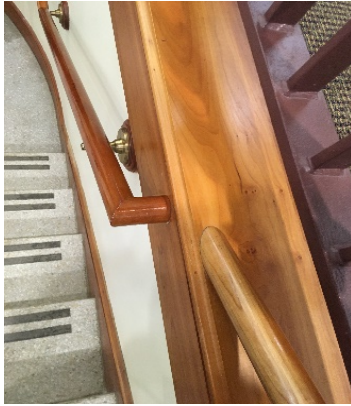
*Discontinuous Handrail*

C2014 Stair Handrails and Balustrades: Handrails are wooden and the railing is metal. The handrail is not continuous.

The discontinuous handrail must be modified to be a continuous handrail as required by MAAB regulations. As it exists, it is a code violation.

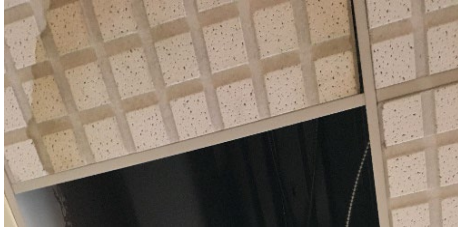
*Stained ceiling tiles.*
